COAL FATAL

1957-0240

UNITED STATES
DEPARTMENT OF THE INTERIOR
BUREAU OF MINES

REPORT OF MULTIPLE FATAL COAL OUTBURST ACCIDENT
MARY HELEN NOS. 2 AND 3 MINES
MARY HELEN COAL CORPORATION
COALGOOD, HARLAN COUNTY, KENTUCKY

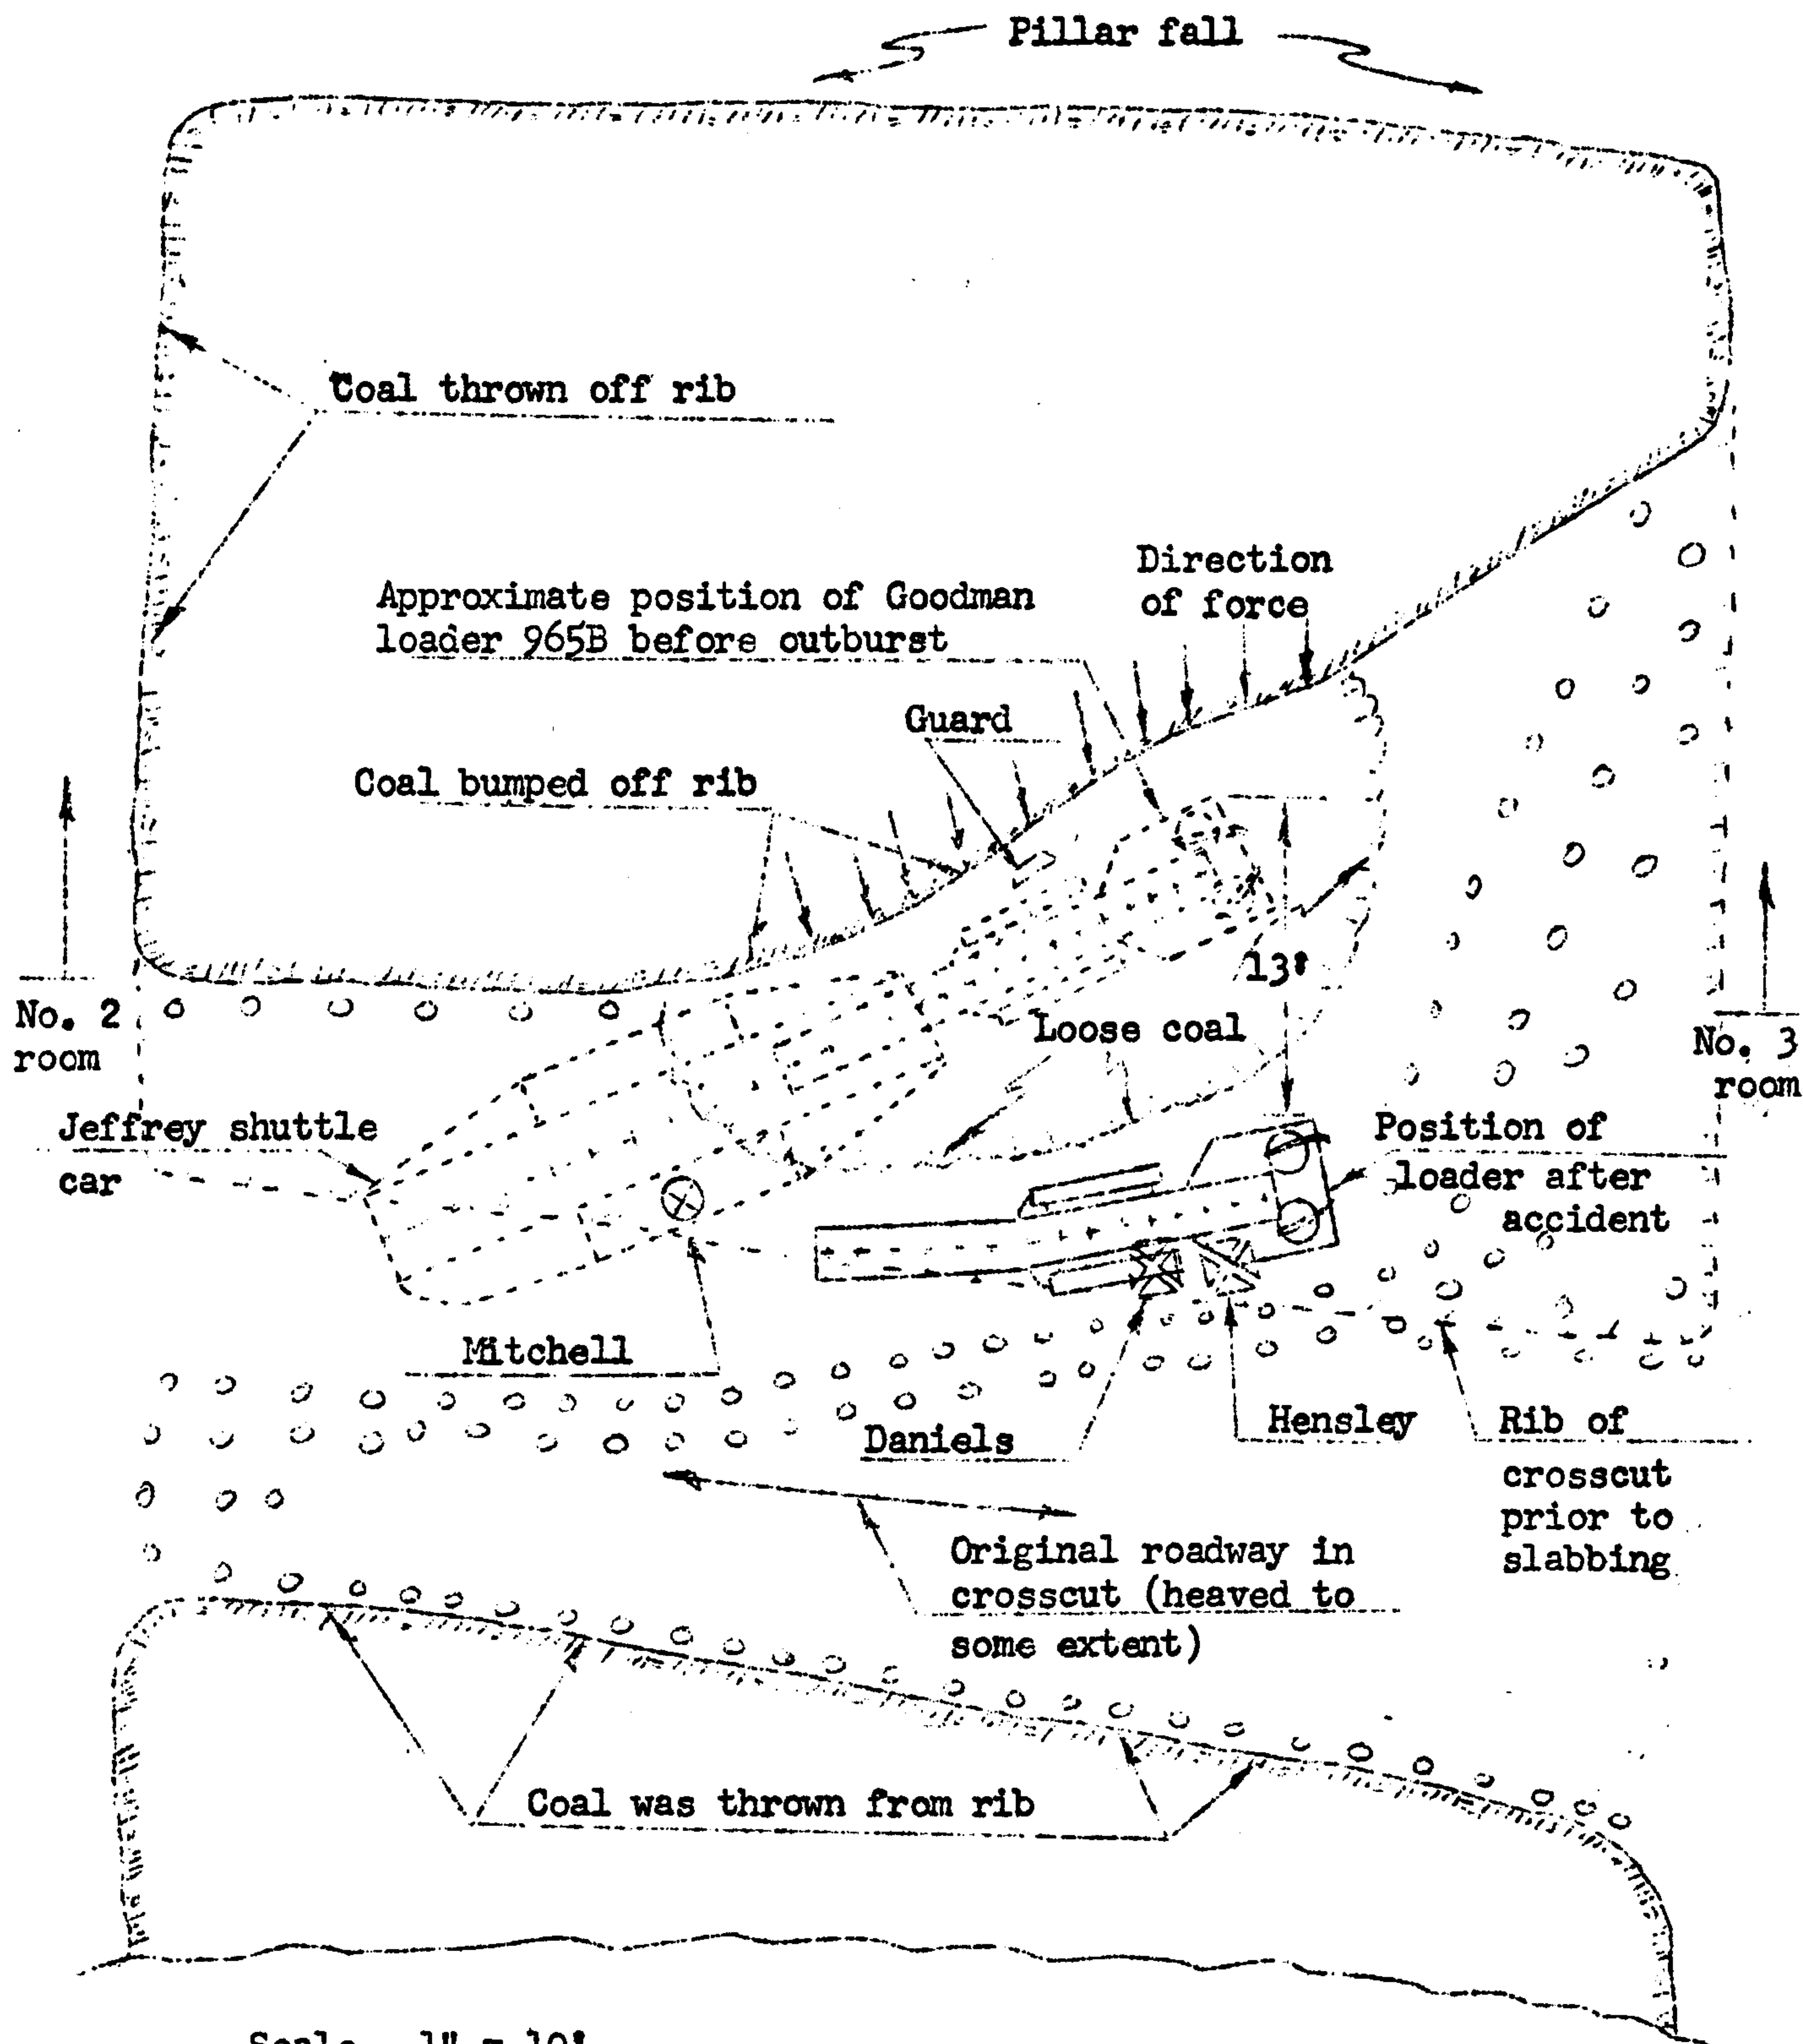
SKETCH NO. 1

The floor of the crosscut between Nos. 2 and 3 rooms had heaved to some extent, and it was decided that a new roadway be made by slabbing along the crosscut side, as indicated in sketch No. 1 appended hereto. It was planned to drive this new roadway until it intersected the No. 3 room and then turn 90° left and drive an open-end lift adjacent to the No. 3 room to the inby end of the pillar. However, when the new roadway adjacent to the crosscut was completed, a definite lift across the back side was not made as planned; instead 45° angle lifts were mined off the pillar until the rib was in the position as shown on the sketch at the time of the accident. This condition resulted in mining coal into the highly stressed area of the block, and when a free face was available the stored energy was released instantaneously with violence.

* Roof was not shaken down nor were timbers knocked out by the bump in the active areas, but the roof opened up at several tension cracks (jointing planes) on about S-80°-W, which is near the angle of the coal cleavage planes, and the original line of extraction. The cracks extended through the bump area, thence into the No. 1 pillar place and into the gob. A large cave occurred several hours after the outburst in the mined-out areas inby the affected pillar. A dense cloud of dust was reported to have been thrown into suspension by the outburst. Damage to property was confined to the bump area where considerable damage was done to the loading machine, and the trailing cable was severed near the machine. *

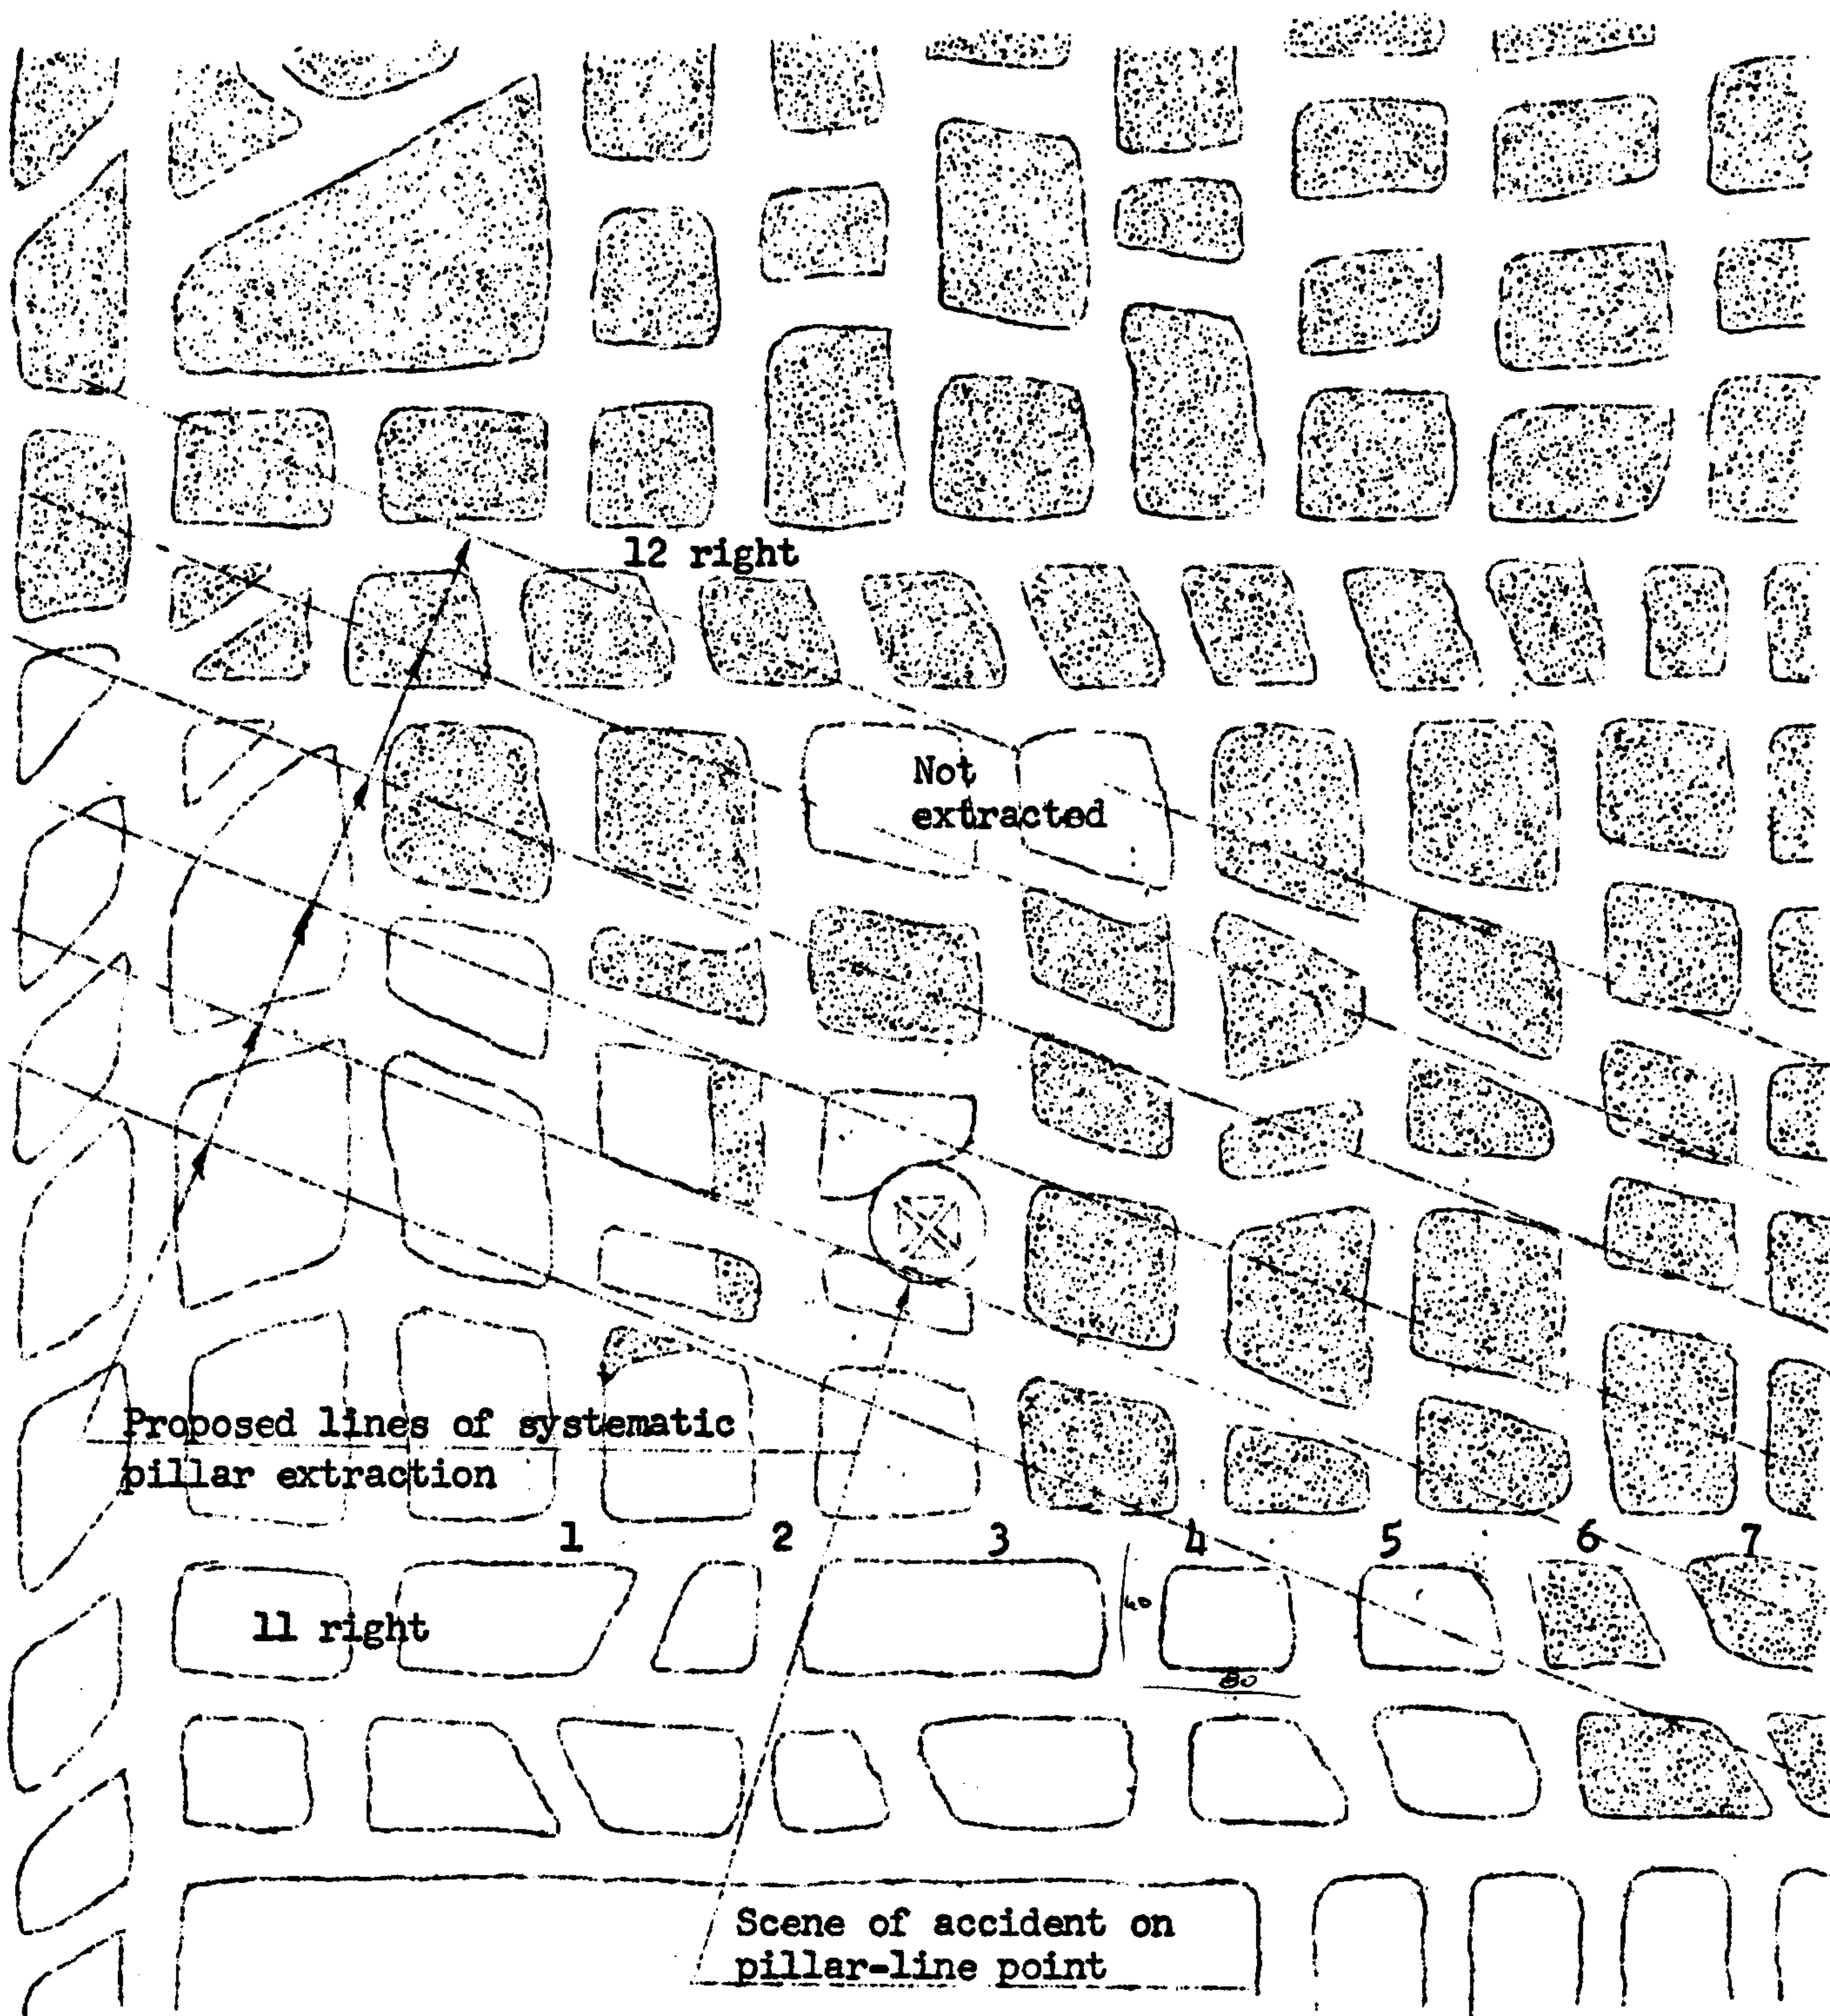
SKETCH NO. 2

The pillars in the immediate area where the outburst occurred were not being mined individually by proper extraction methods nor in proper sequence as indicated in sketch No. 2 of this report. Furthermore, it will be noted that two pillars of coal had been left unmined in by the affected pillar, reportedly, because about 75 inches of draw rock was coming with the coal, leaving about a 100-foot span between the affected pillar and the unmined pillar. These two unmined pillars probably prevented the massive sandstone from caving as it should, and thus imposed additional stress on the unmined pillars. The natural conditions existing in these mines, such as the character of the coal, the roof, and the floor, and the depth of the overburden are factors which favor outbursts in coal mines, especially in highly stressed areas.

A violent coal outburst from an over-stressed pillar, which resulted from failure to remove the coal from pillars according to the adopted plan of pillar recovery was the direct cause of the accident.

1. Pillars should be recovered in the proper sequence and in a straight and orderly manner so as to reduce the possibility of offset pillar lines, pillar line points, or points projecting into gobs.

2. Pillar recovery sections should be projected and developed so that the pillars will, as far as practical, be of the same size so that each pillar will bear an equal amount of overburden weight or stresses.

3. Pillars should always be recovered by open-end lifts. The lifts should be driven so that each lift and adjacent consecutive lifts will be made along the gob side of the pillars. Only one lift should be made in a pillar at a time and should be driven only sufficiently wide to accomodate the equipment and to provide adequate roof support. Pillars on or near the line of extraction should not be split.

4. Every effort should be made to obtain full recovery of pillars so that pillars or stumps will not be left unmined to impede or prevent the roof from caving in worked-out areas.
